# Manhole Inspection Summary

Manhole # S27U\_\_008MH

**Inspection** ☐ Is Incomplete Rating: **4) Poor**

**Location** Address: **1621 Ridgley st**

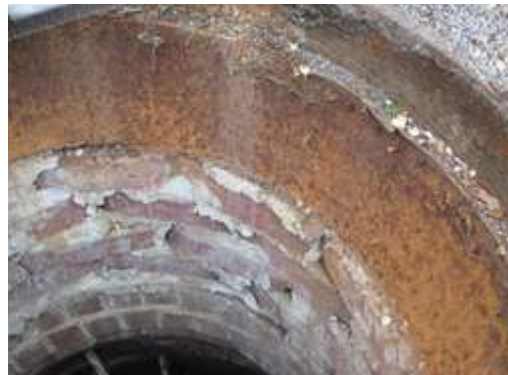
Cover View

rusted frame

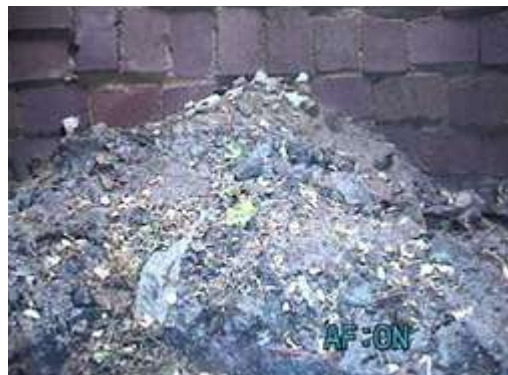
Defect 1

Condition: ☐ Sound ☐ Cracked ☐ Root Intrusion ☐ Deteriorated ☐ Leaks ☒ **Debris**

debris on bench 2' feet

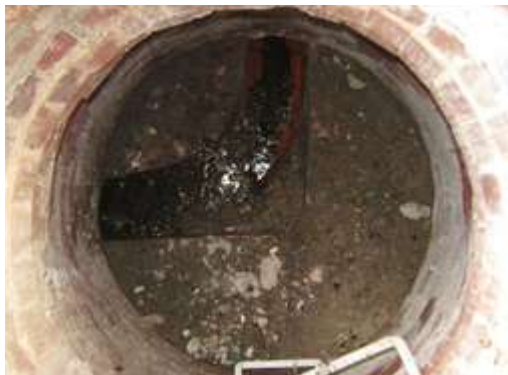
### Defect 2

Condition: ☐ Sound ☐ Cracked ☐ Root Intrusion ☐ Deteriorated ☐ Leaks ☒ **Debris**

channel debris

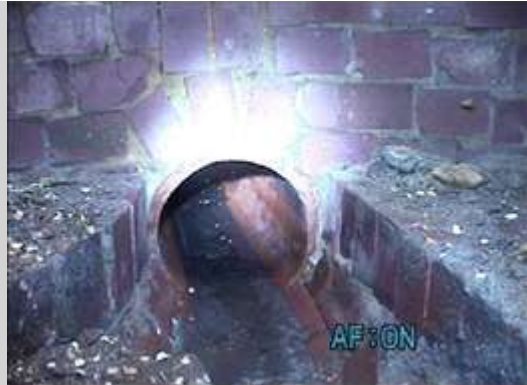
12 O'Clock Outflow

8 in. Circular Gravity Sewer  
Pipe Out @ 12 O'Clock

Pipe Height: **8.4** (in.) Rod and Bar (Angled)  
Pipe Material: **Clay** ☐ Pipe Lined  
Invert Depth: **7.26** (ft.) Flow Characteristics: **Slow**  
Deposits: ☒ None ☐ **Mud** ☐ Sludge ☐ Debris ☐ Grease  
Silt Depth: **0** (in.) Deposits Extent:  
Infiltration: **None** Pipe Seal Cond: **Sound**

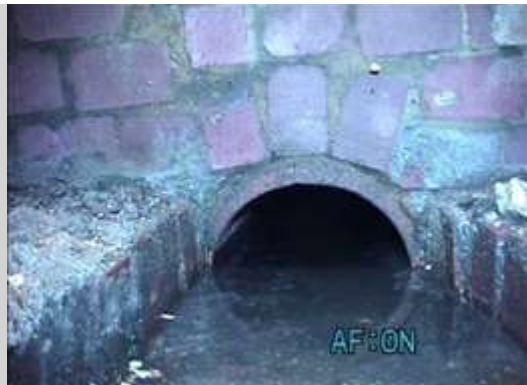
9 O'Clock Inflow

8 in. Circular Gravity Sewer  
Pipe In @ 9 O'Clock

Pipe Height: **8.4** (in.) Rod and Bar (Angled)  
Pipe Material: **Clay** ☐ Pipe Lined  
Invert Depth: **7.25** (ft.) Flow Characteristics: **Slow**  
Deposits: ☐ None ☒ **Mud** ☐ Sludge ☐ Debris ☐ Grease  
Silt Depth: **4** (in.) Deposits Extent: **Medium**  
Infiltration: **None** Pipe Seal Cond: **Sound**
